**WOOD PROTECTION COMPANY
SITE INSPECTION**

**Texas Water Commission
State Superfund Unit**

Re: Site Inspection of Wood Protection Company
JN 117203
TWC 14-70020

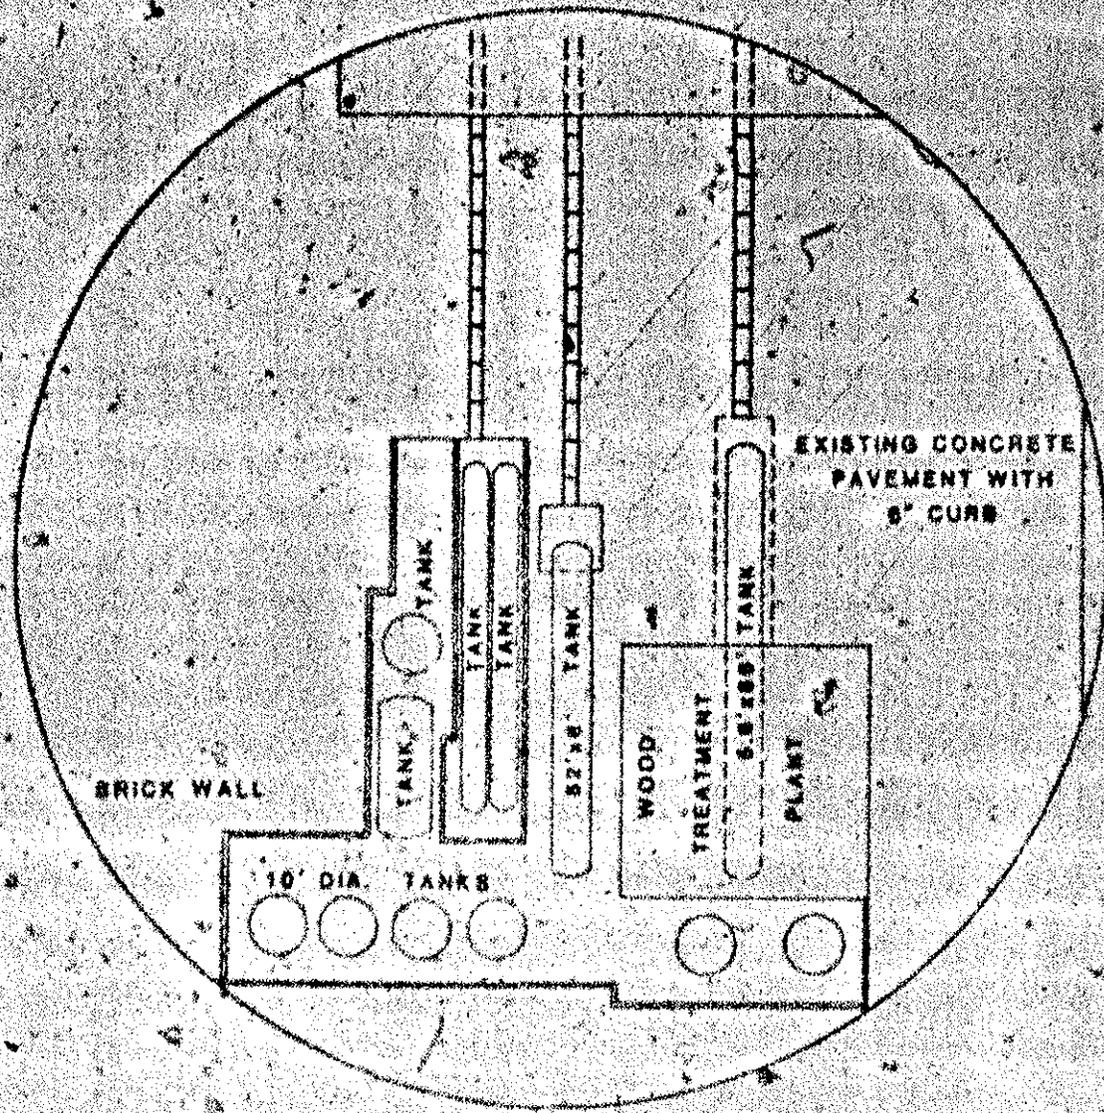
WOOD PROTECTION CO
SITE FEATURES MAP
Figure 1

A walk through inspection of the facility was undertaken. It was stated that the facility at this site had been in operation since 1952. Some plant expansion over the years has led to the current configuration (see Figure 1). The plant consists of three pressure cylinders. Steam is not used in the process.

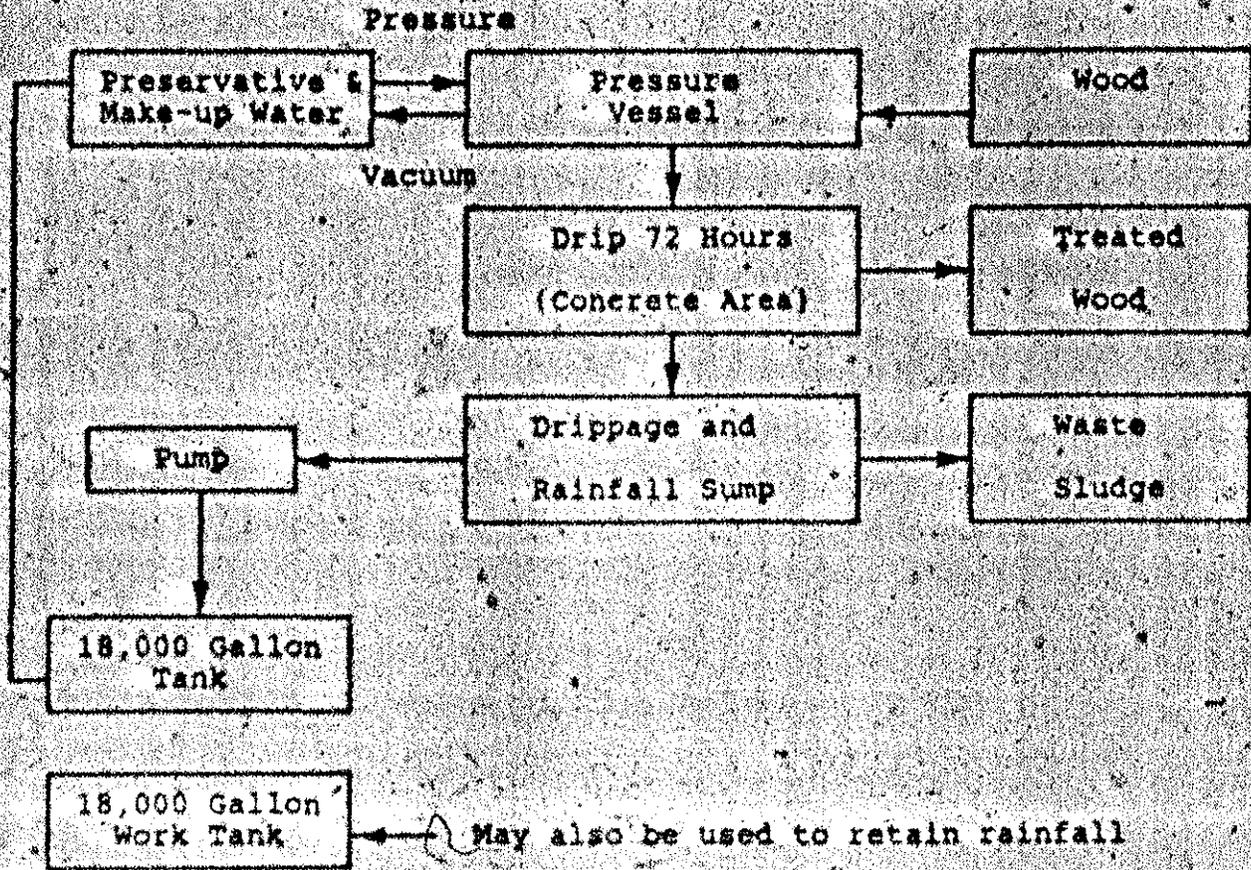
Figure 3
WOOD PROTECTION COMPANY
PROCESS FLOW CHART

Figure 2 shows site photographs. Overall the photographs document the clean and neat appearance of the facility. No conditions were found which would lead to sample acquisition at this site. The occasional waste storage in drums was inside a curbed area within a roofed and walled building in an area co-located with unregulated product storage (see Photo 1). Tankage has secondary containment (see Photo #2) and facilities appear to have adequate capacity to manage rainfall. Piping apparently allows for use of several tanks should the need arise. (The entire manufacturing process area has a concrete base which is gently sloping to drains and sumps to collect rainfall and divert run-on from nonprocess areas (see Photos #3 and #4). Figure 3 is a flow diagram of the process at WPC.
